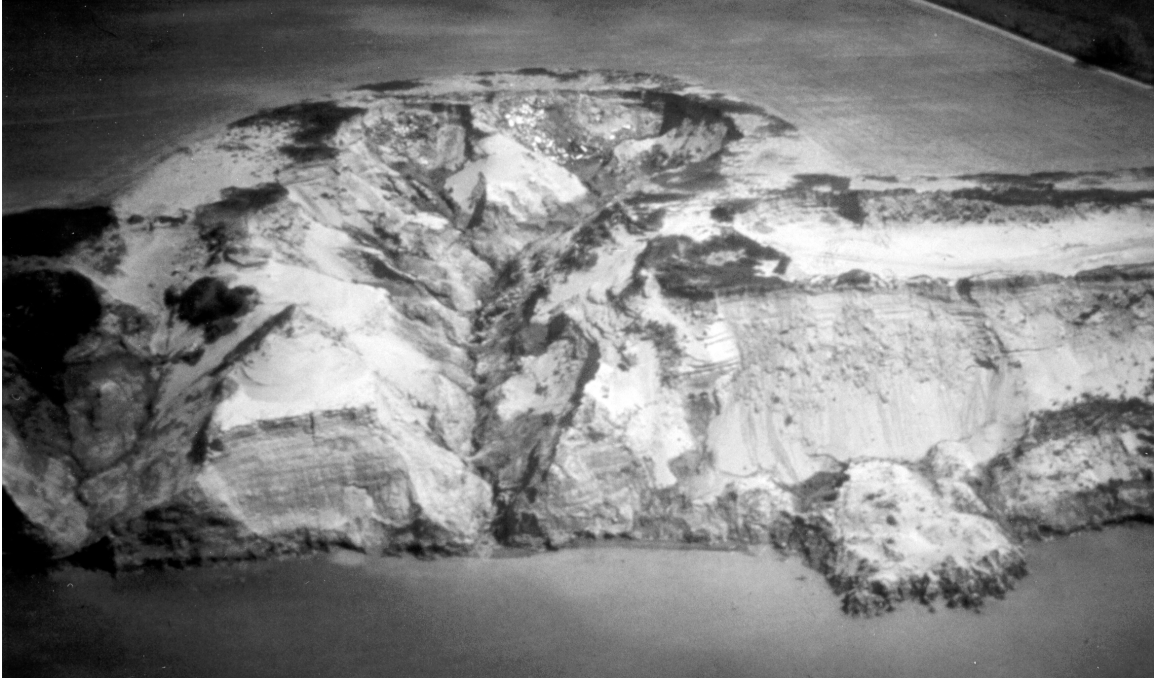
Figure III-5-22. Gully erosion of a bluff along the north central shore of Lake Erie

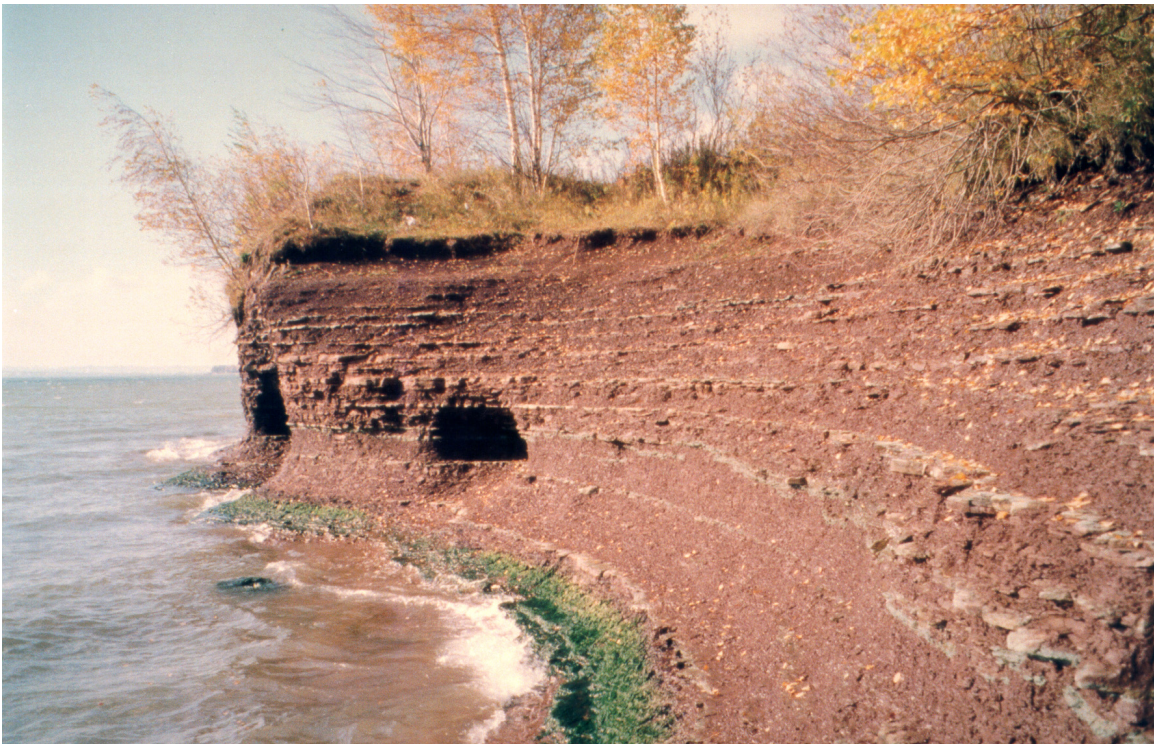
Figure III-5-23. An eroding shale bluff along the west Lake Ontario shoreline
